**CASE REPORT**

# “Detachment of the carinal hook following endobronchial intubation with a double lumen tube”

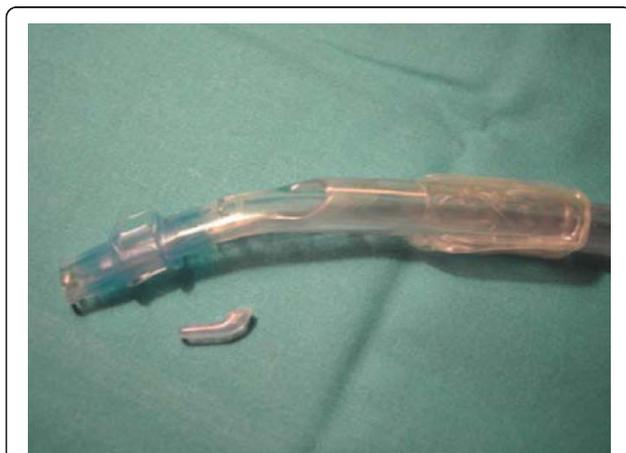
**Figure 1** Amputation of the carinal hook (arrows) in a left-sided polyvinylchloride Carlens DLT (SUMI<sup>®</sup>, Portex Inc., Mexico).

The exact mechanism leading to the amputation of the carinal hook is obscure. Rigid structures, narrow passages and manufacturing defect are possible [7].

In this case, desaturation and resistance to manual ventilation have alerted to a probably malpositioned DLT. In fact, tracheal narrowing was visualized by conventional laryngoscopy and insertion of the DLT occurred with some difficulties. The potential cause for the hook detachment was a narrowed trachea. Prompt action to remove the airway foreign body by bronchoscopy solved the patient's problem without adverse consequences. Although fiberoptic bronchoscopy is the accepted standard for appropriate positioning and confirmation of DLT [8], it was not performed in the first attempt. No double-lumen tube positioning method is fail-safe and unsuccessful replacement of another DLT with the aid of fiberoptic bronchoscopy occurred.

The present case has demonstrated that carinal hooks can be hazardous. It also highlights the importance of the availability of fiberoptic equipment in the operating theatre to promote proper DLT positioning and inspection of the carinal hook DLT, to reconfirm that no amputation had occurred.

Assuming a manufacturing defect of the 37F left-sided polyvinylchloride Carlens DLT (SUMI<sup>®</sup>, Portex Inc., Mexico.), until now no answer regarding the event was given by the DLT company.
